# Fatigue Crack Growth Behavior of a Single Crystal Alloy as Observed Through an In Situ Fatigue Loading Stage

Jack Telesman and Peter Kantzos  
*Lewis Research Center*  
*Cleveland, Ohio*

Prepared for the  
SAMPE Metals Processing Conference  
Dayton, Ohio, August 2-4, 1988

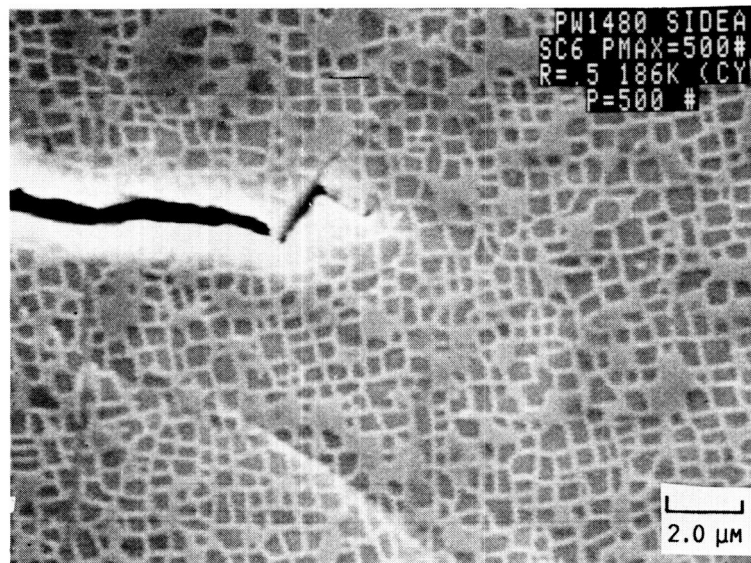
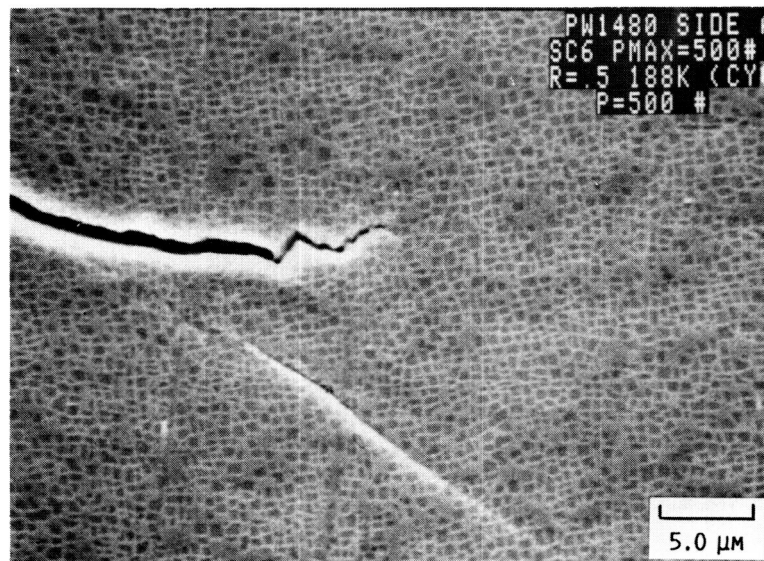
(a) 186 000 CYCLES.

(b) 188 000 CYCLES.

FIGURE 10. - THE SEQUENCE OF CRACK INITIATION AND LINKUP OF  
SLIP BAND CRACKS WITH THE MAIN CRACK (MICROGRAPHS TAKEN  
AT MAXIMUM LOAD).

(c) 190 000 CYCLES.

(d) 204 000 CYCLES.

The other type of crack branching mechanism encountered consisted of a crack nucleating ahead of the main crack, followed by the coalescence of the two cracks slightly behind the original crack tip. This sequence of events is illustrated in Fig. 10. As shown, crack nucleation was preceded by formation of a slip band (Fig. 10(a) and 10(b)), followed by an initiation of another crack ahead of the crack tip on a parallel slip band (Fig. 10(c)), and finally the coalescence of the three cracks (Fig. 10(d)). Post failure evaluations of some of the events described above, revealed that the surface observations can at times be misleading. What may appear on the surface to be the initiation of an entirely new crack, may in fact be the surfacing of a branched, subsurfaced, region of the main crack.

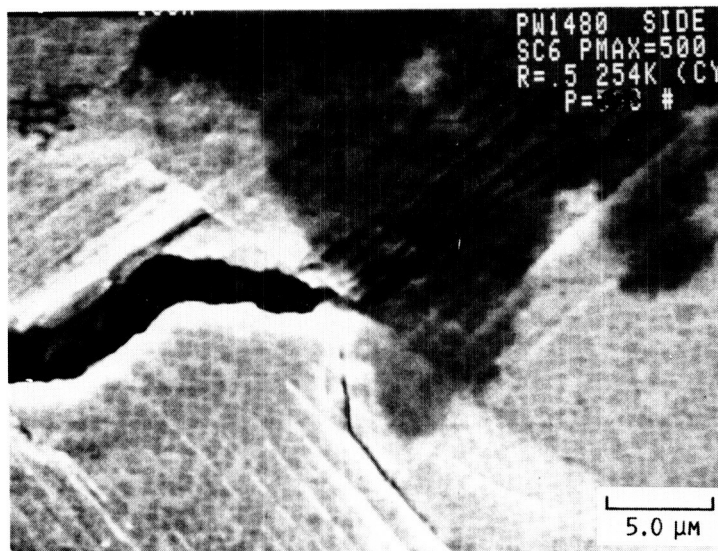
(a) 2220 N (500 LB).

(b) 2220 N (500 LB).

FIGURE 11. - THREE MECHANISMS OF CRACK CLOSURE ARE: ROUGH-  
NESS INDUCED (a), DEBRIS FORMATION (b), AND THE EFFECT  
OF MIXED MODE LOADING (c) AND (d).

(c) 2220 N (500 LB).

(d) 1335 N (300 LB).

Three different mechanisms of crack closure were observed to occur in this nickel-based superalloy single crystal. Due to the high degree of tortuosity of the crack path, interlocking of asperities occurred in the crack wake as demonstrated in Fig. 11(a) (roughness induced closure). Another method by which crack closure was found to occur was through the lodging of debris, formed during the fatigue processes, between the two cracked surfaces (Fig. 11(b)). Crack closure was also found to depend upon the mode of loading in the crack segments near the crack tip. This was probably the most common and important mechanism of crack closure. Segments of the crack which experienced mostly Mode I loading (tensile type), exhibited the largest crack tip opening displacements (CTOD) and tended to remain open throughout most of the loading cycle. Other segments, subjected to mixed-mode loading (combination of tensile and shear), exhibited much smaller CTOD and were closed for considerably longer portions of the loading cycle. This behavior is clearly shown in Figs. 11(c) and 11(d). The larger magnitude of

crack closure of the inclined crack subjected to mixed mode loading, may have contributed to its lower observed FCG rates since the crack tip was closed for longer portions of the loading cycle.
